**Fire Station Renovation and  
Police Station Addition**  
Building 7200 - Camp Joseph T. Robinson  
North Little Rock, Arkansas

CONTENTS  
ROOF PLAN

**A2.4**

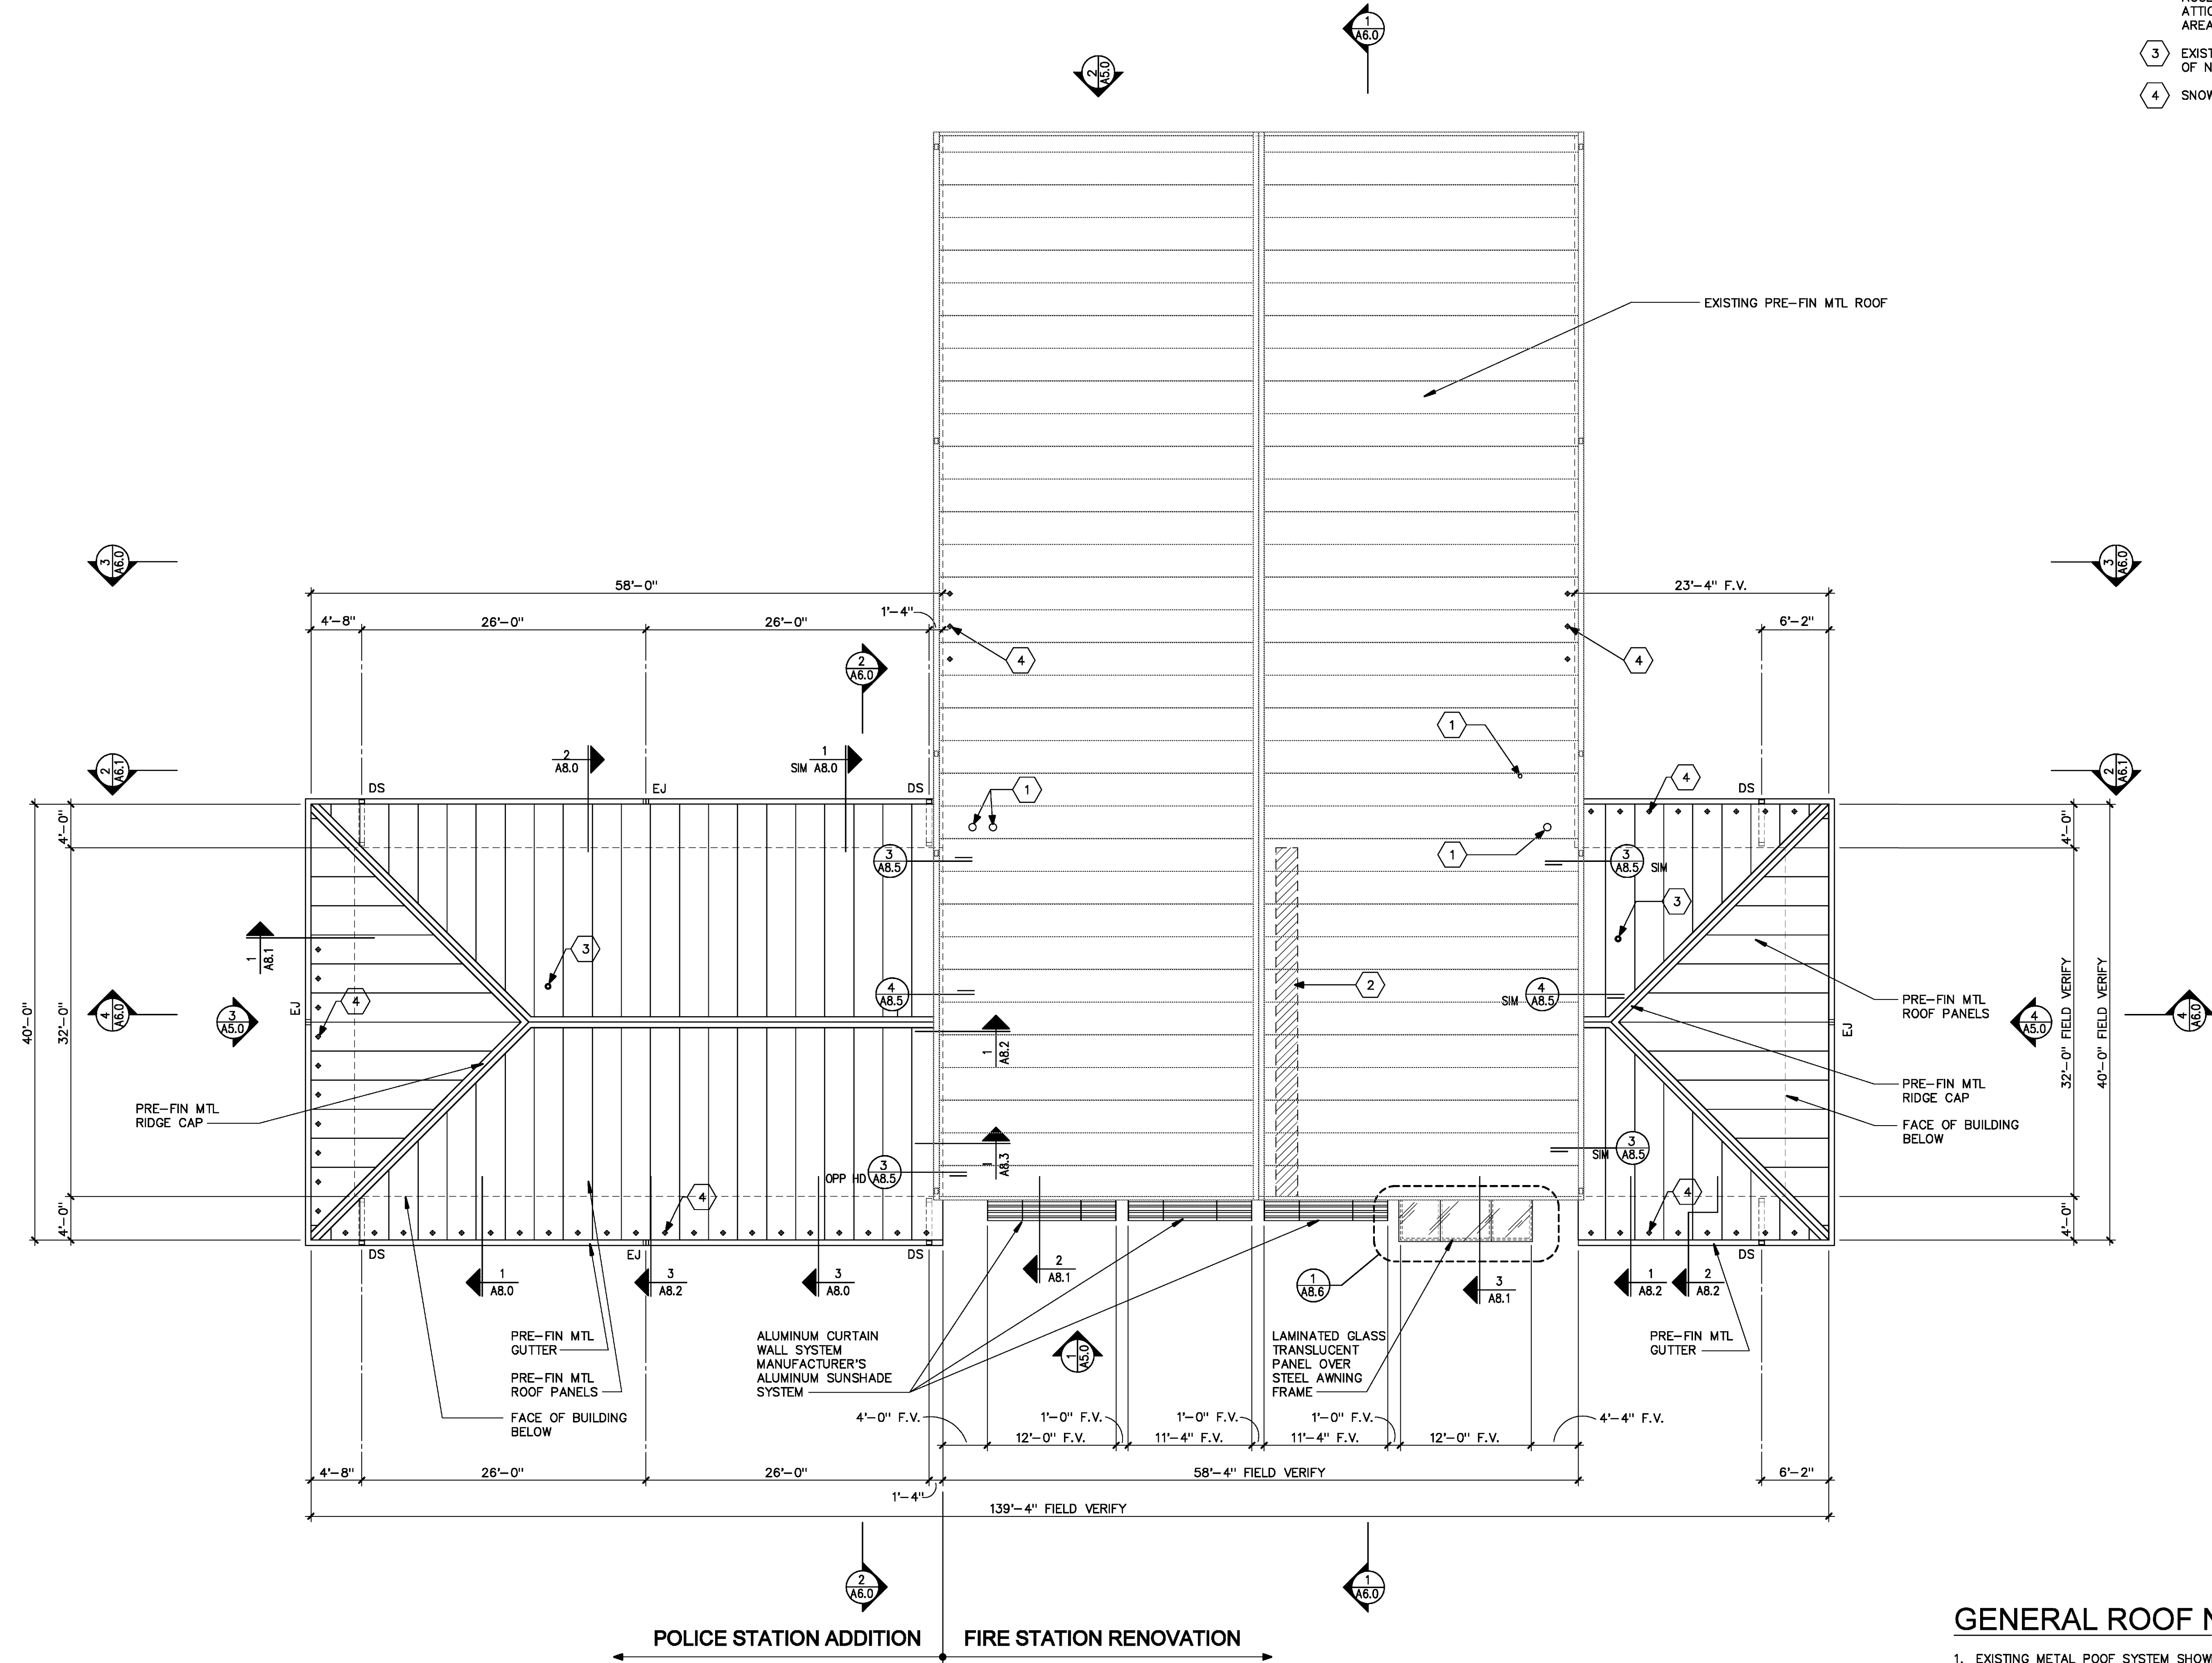
**1 ROOF PLAN**  
1/8" = 1'-0"

- 1 PATCH HOLE IN EXISTING PRE-FIN MTL ROOF WHERE VENT THROUGH ROOF WAS REMOVED.
- 2 PROVIDE A 2'-0" WIDE 3/4" PLYWOOD SUB-FLOOR OVER THE BOTTOM CHORD OF THE EXISTING TRUSSES STARTING AT THE EXISTING ATTIC ACCESS DOOR AND EXTENDING TO THE INSIDE FACE OF THE GABLE ATTIC WALL OPPOSITE THE ATTIC ACCESS DOOR AS SHOWN AT HATCHED AREA.
- 3 EXISTING PLUMBING VENT THROUGH ROOF. SEE MEP FOR CONNECTION OF NEW UTILITIES TO EXISTING VENT THROUGH ROOF.
- 4 SNOW GUARD
